Atrial Septum Tearing due to Balloon Sizing in ASD Device Implantation

Radityo Prakoso, Indriwanto S Atmosudigdo, Poppy S Roebiono, Oktavia Lilyasari, Anna Ulfa Rahajoe, Ganesja M Harimurti

National Cardiovascular Center Harapan Kita

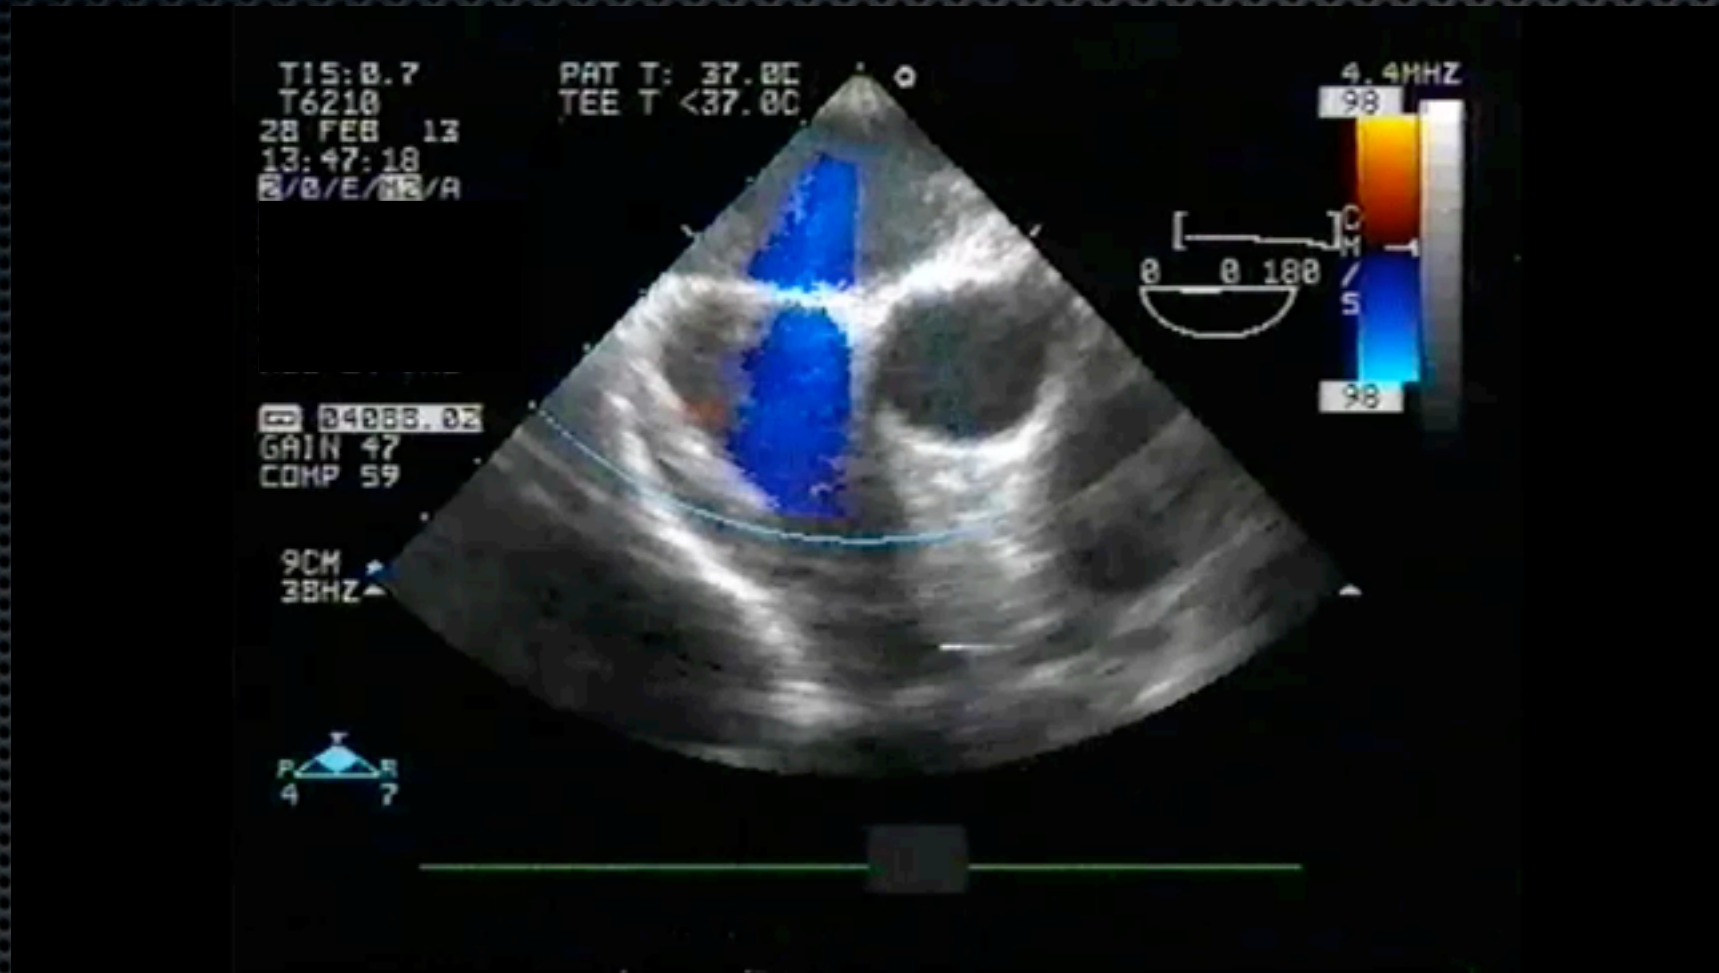
The Procedures

- ✦ Patient was intubated, TEE was performed
- ✦ TEE finding was 15x14mm; diameter : 15mm

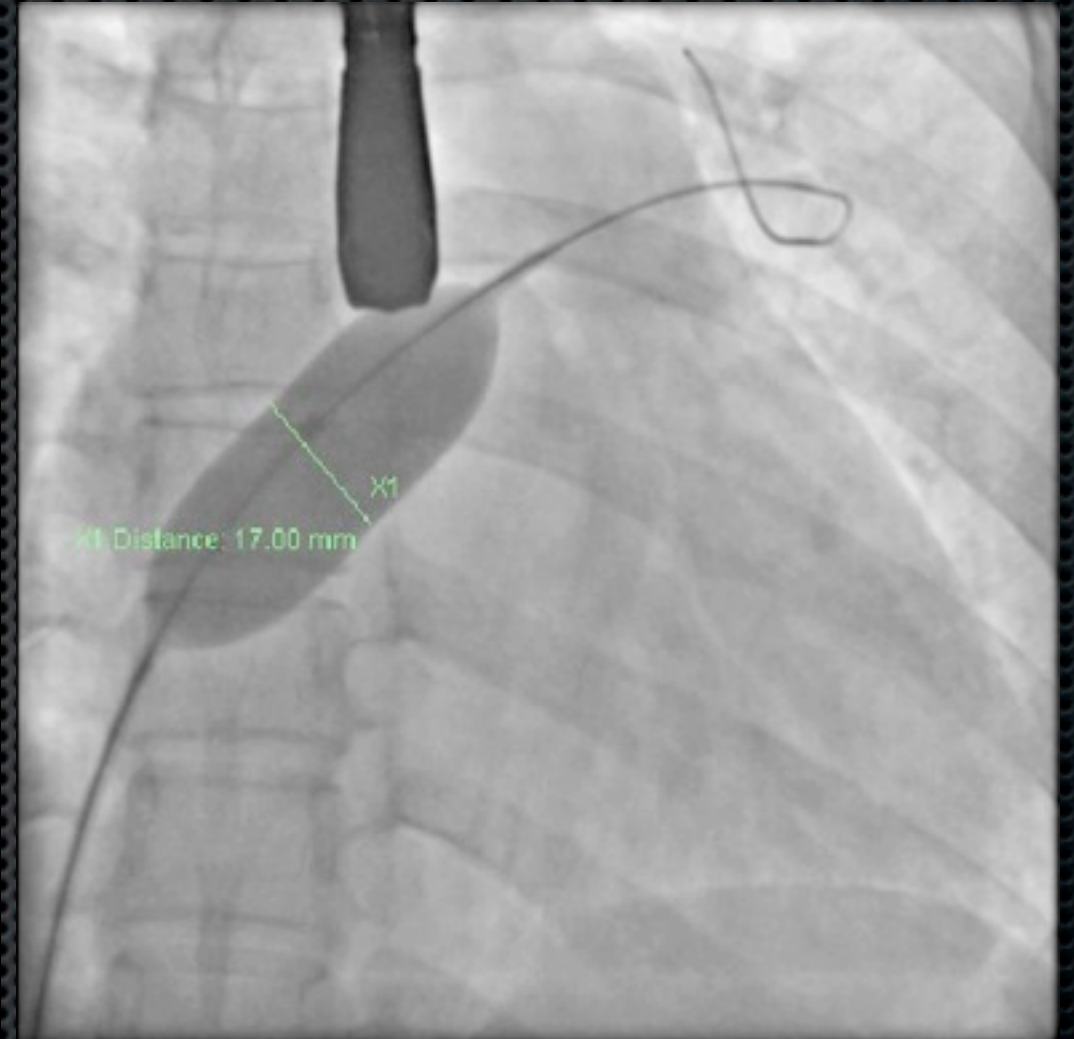
- ✦ Transvenous approach was done to do the balloon sizing
- ✦ Balloon sizing diameter 17mm

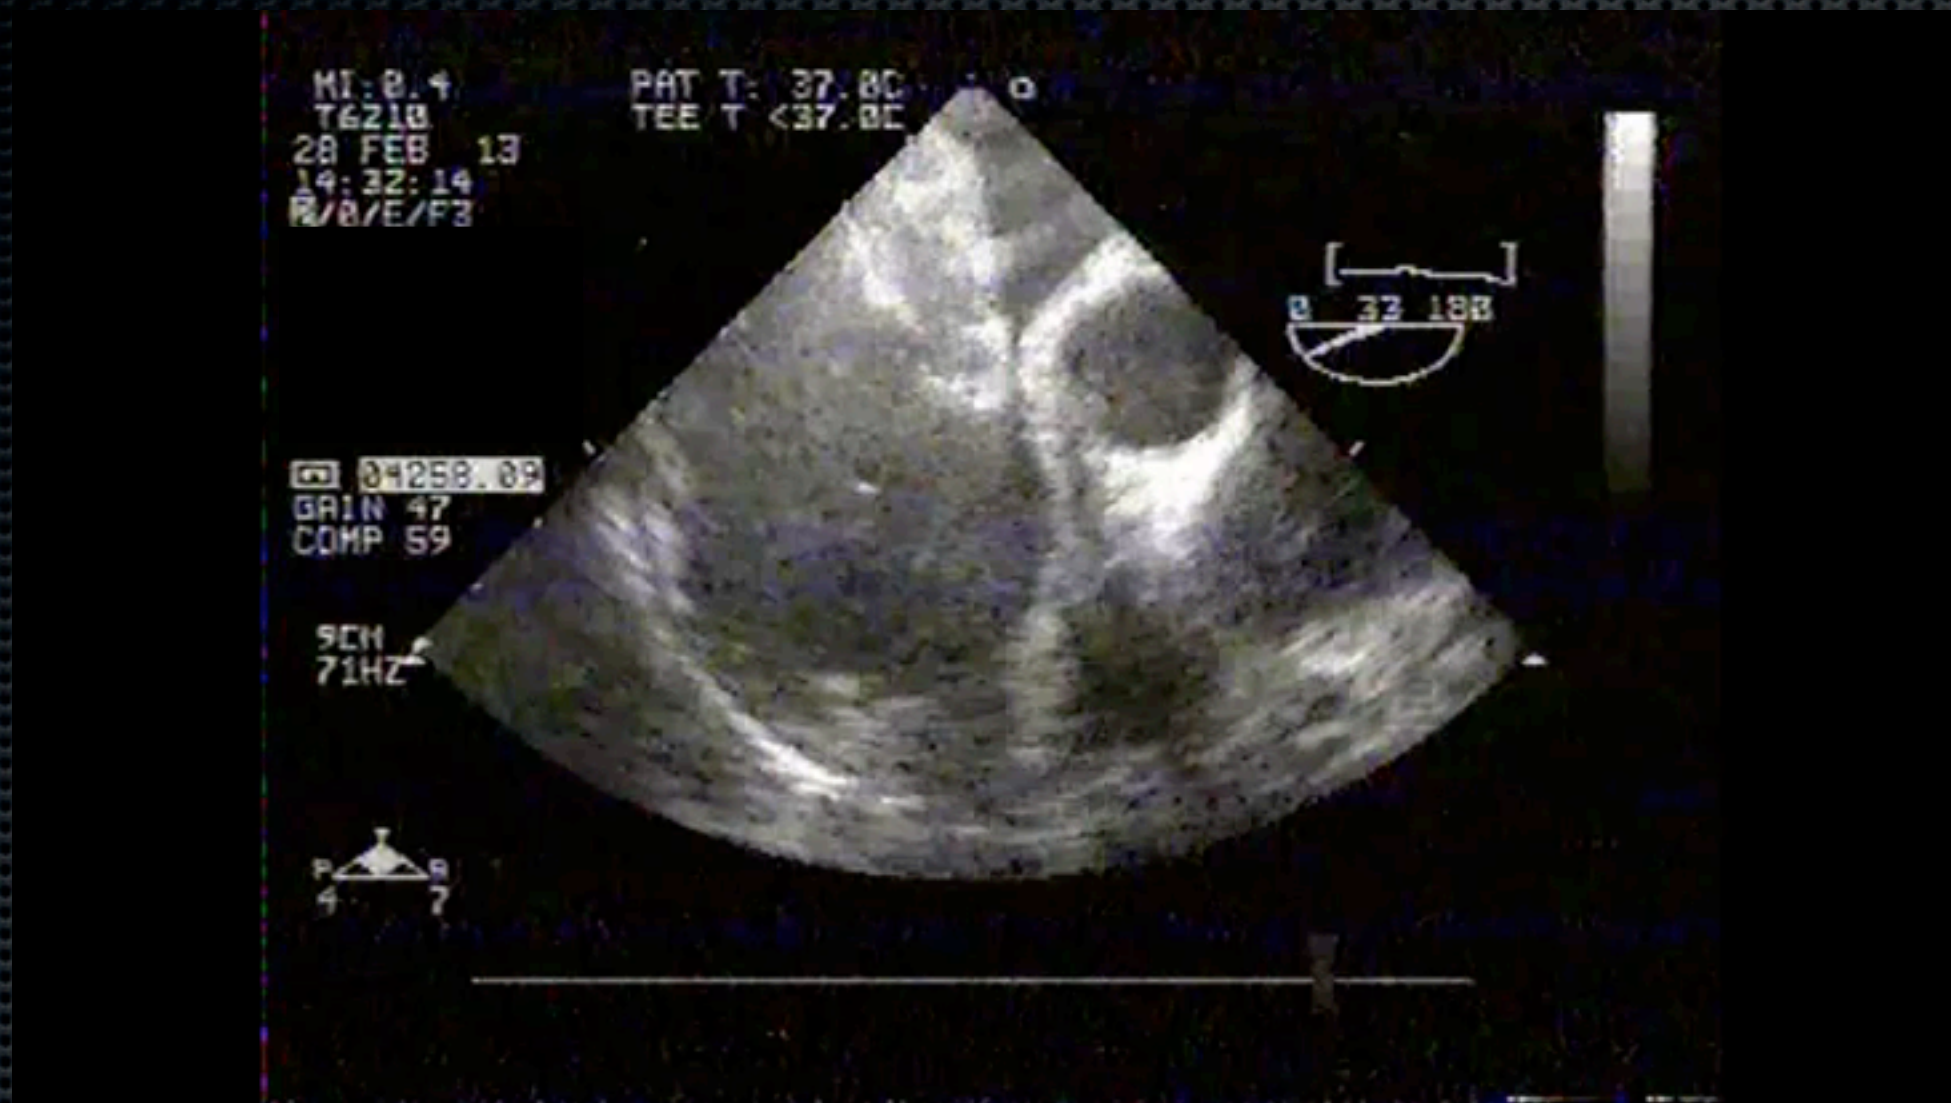
- ✦ The device used was ASO no. 20
- ✦ The device was not properly stowed

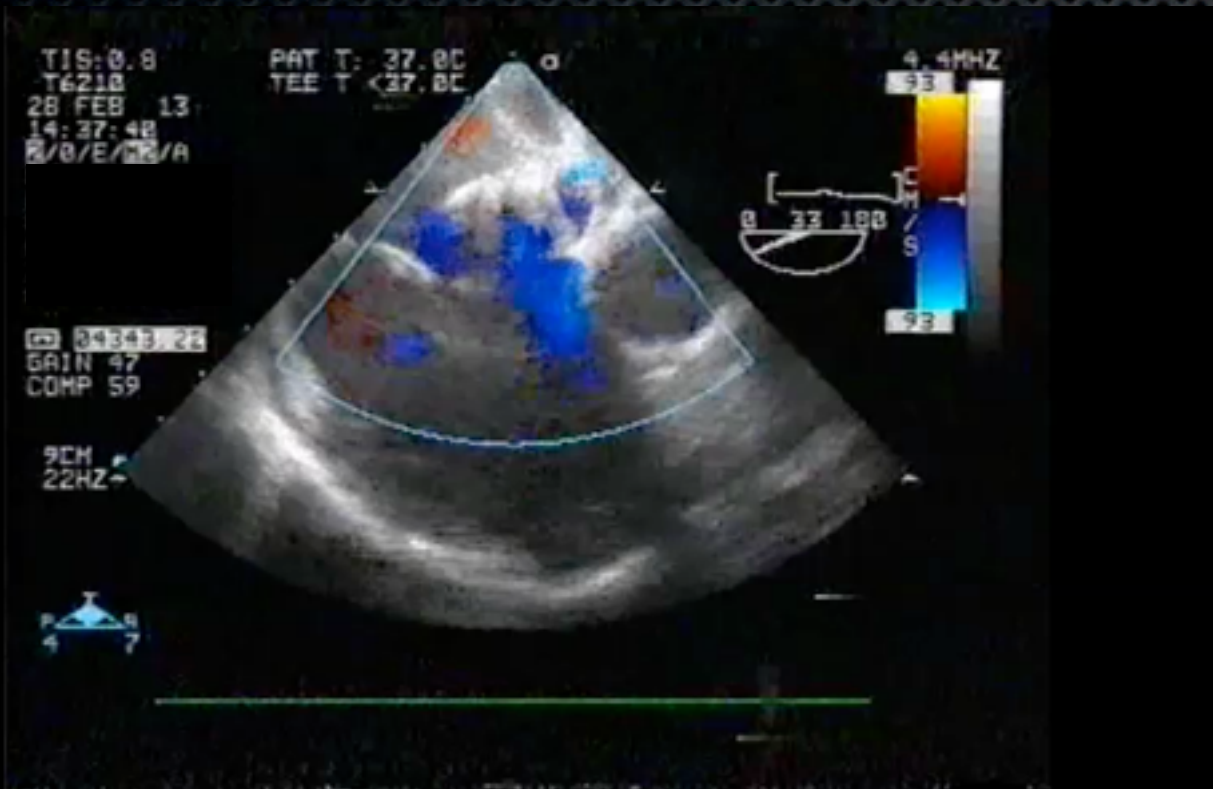
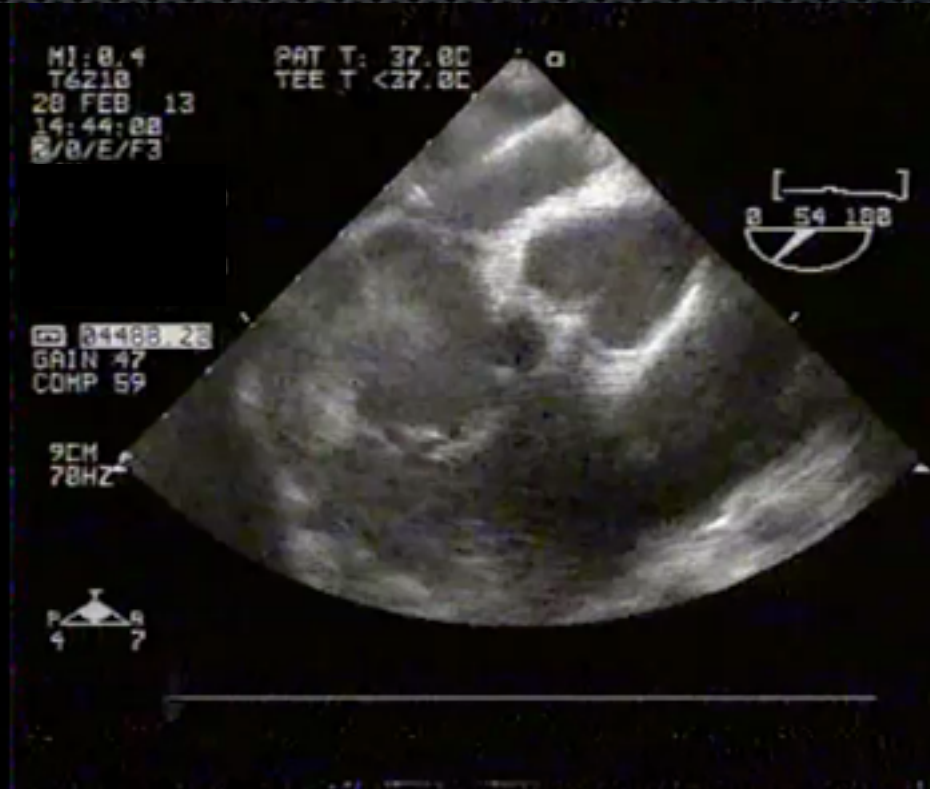
- The atrial septum was torn

- ✦ The possible causes of atrial tearing
 - ✦ Sizing balloon manipulation
 - ✦ passing the guide wire through a small atrial septum fenestration
 - ✦ over stretching the sizing balloon

- ✦ In our case, Balloon over-stretching until waist is developed or balloon manipulation has been suspected of the cause.
- ✦ TEE provide proofed data to evaluate size the secundum ASD prior device implantation

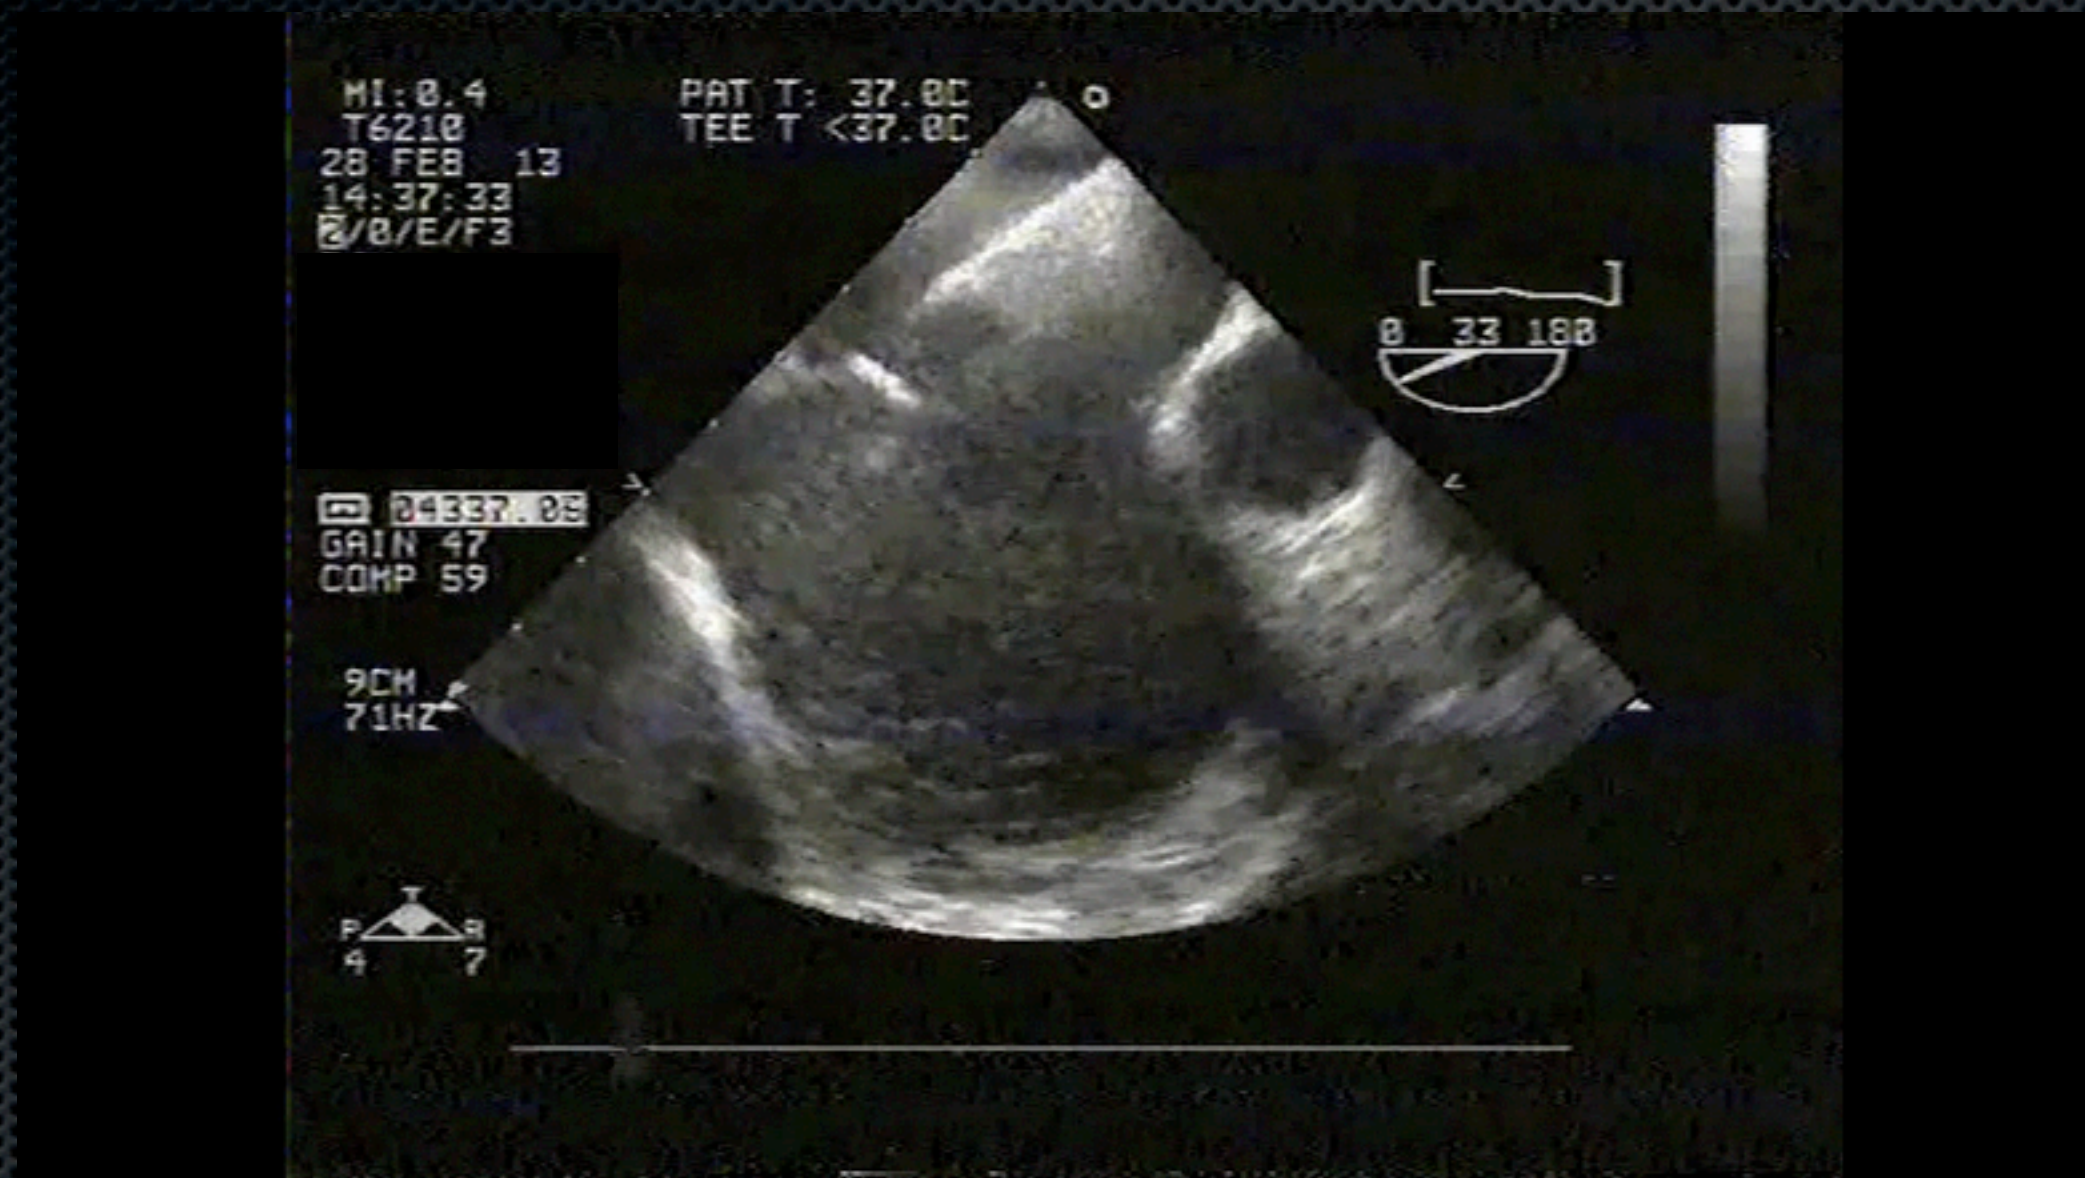
Bigger device was inserted (ASO no.26)

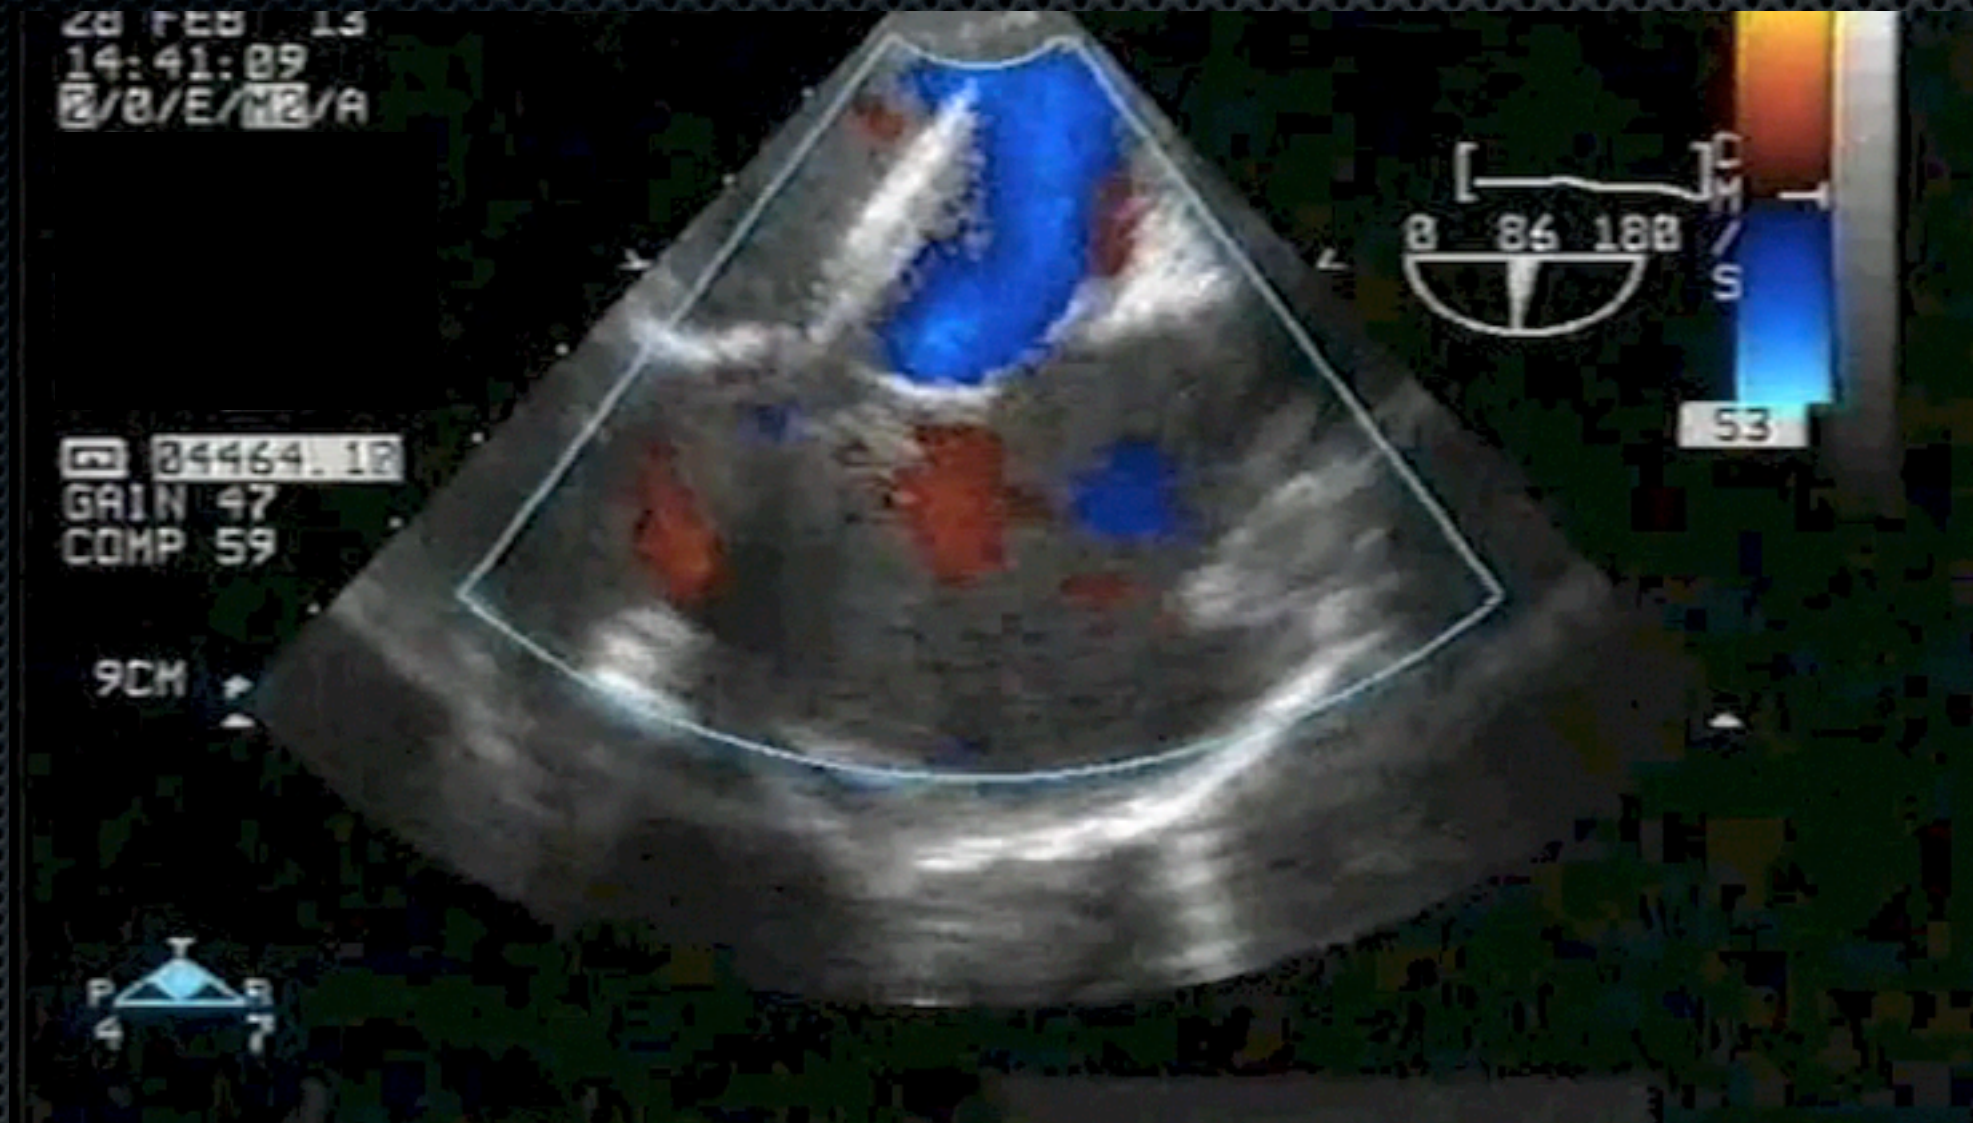
There was tearing expansion (31mm)

- However, The ASO implantation in this patient was failed during the procedure because of the expanding ASD diameter due to loss of the previously thin septum
- Therefore, we decide to close the ASD surgically.

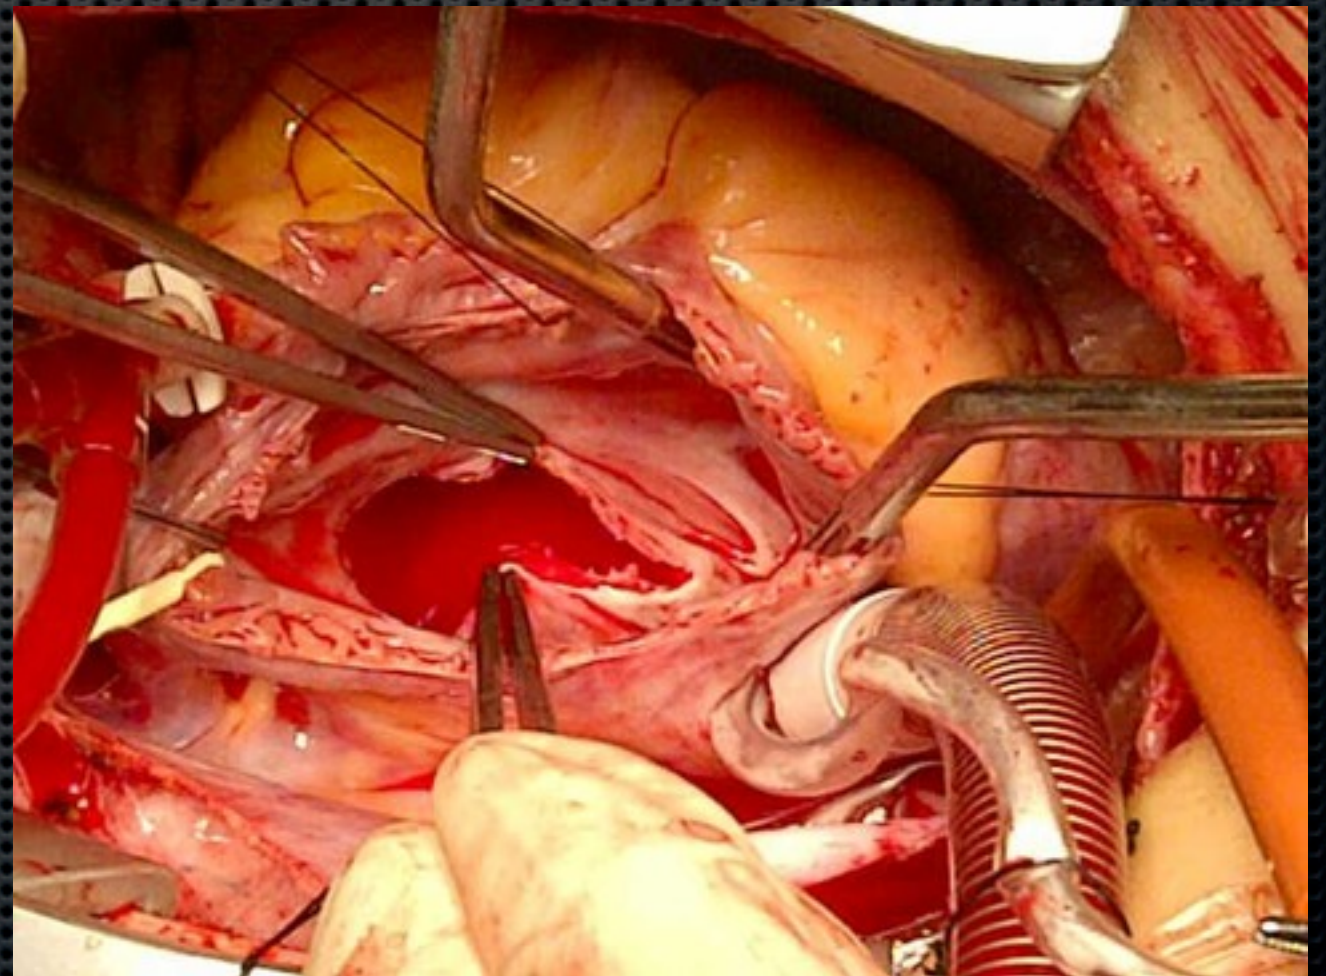
ASD Closure

- ✦ From the operation report, we found that the diameter of ASD secundum is expanding from 16mm to 40mm with new tear towards the inferior vena cava. Then the defect were closed with pericardial patch.
