TCT Asia 2010

Structural Damage During Percutaneous Aortic Valve Replacement

Eberhard Grube MD

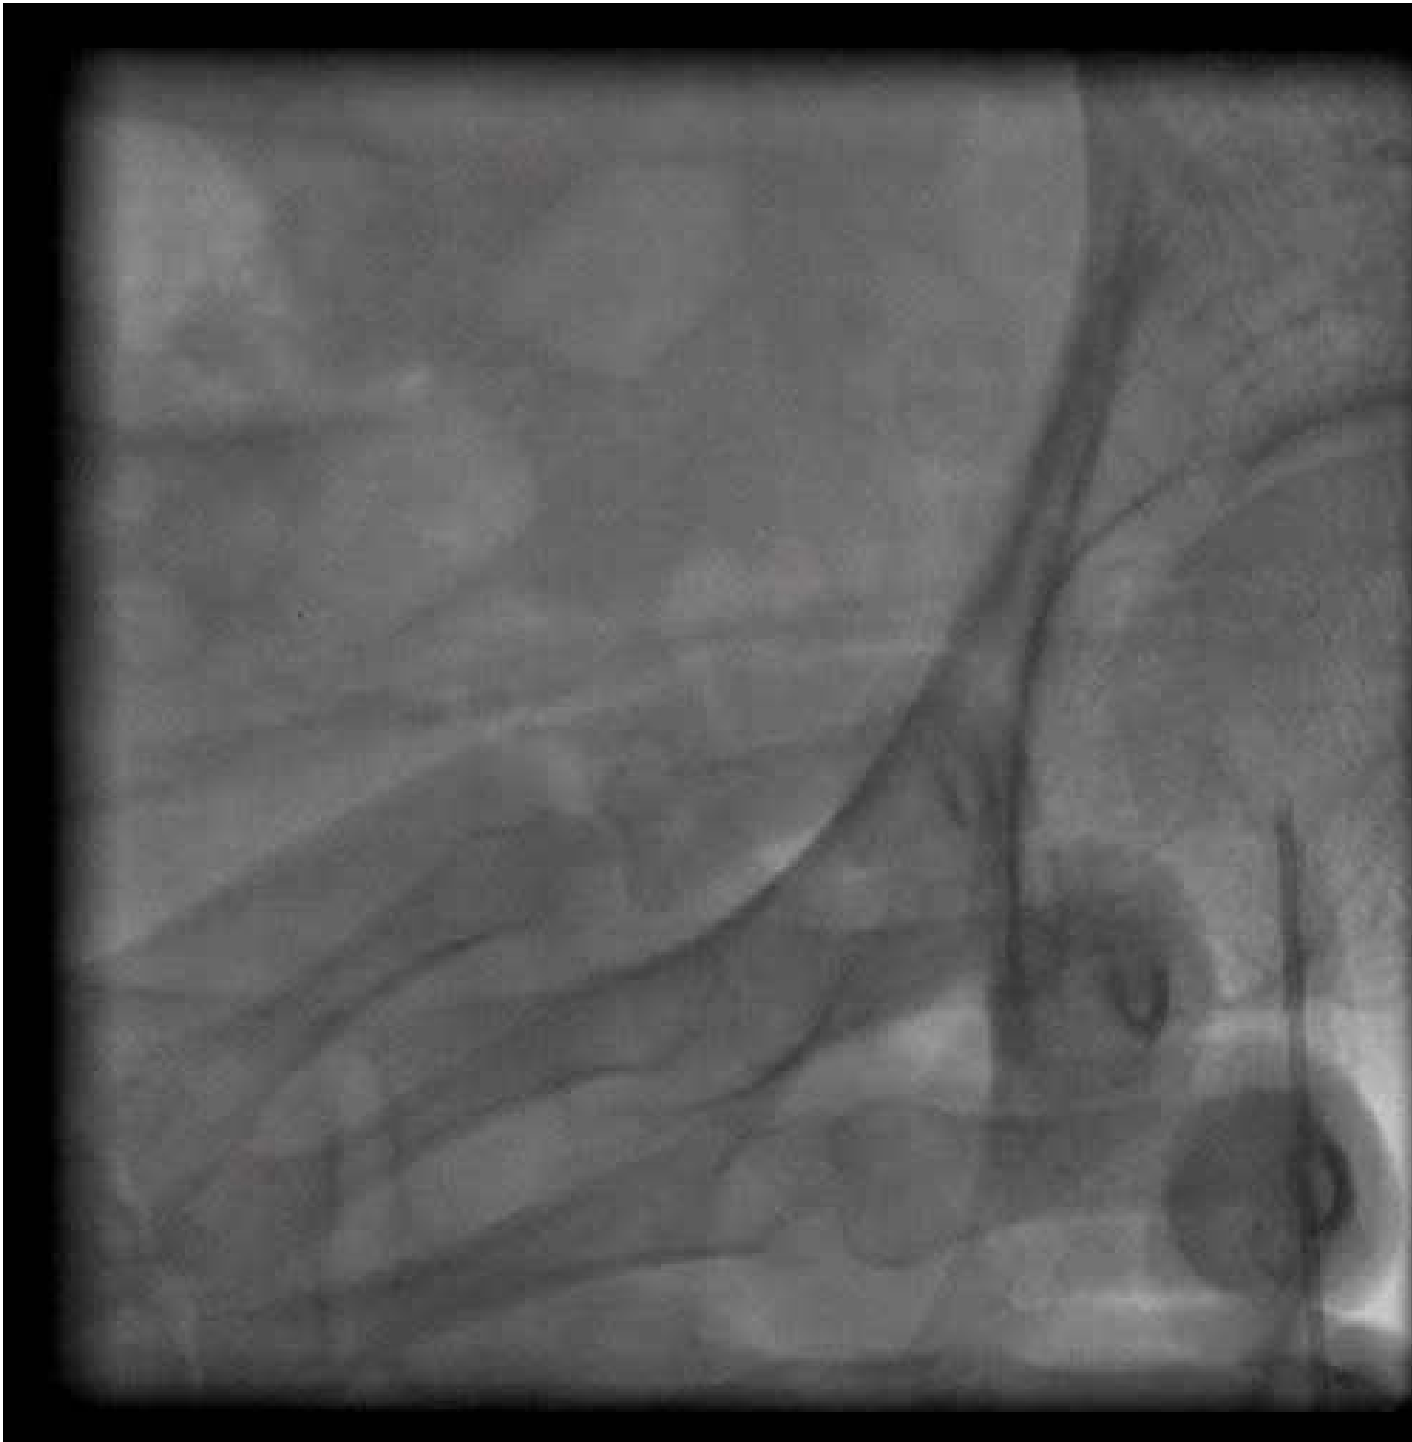
Regular
Puncture
under Angio
Guidance

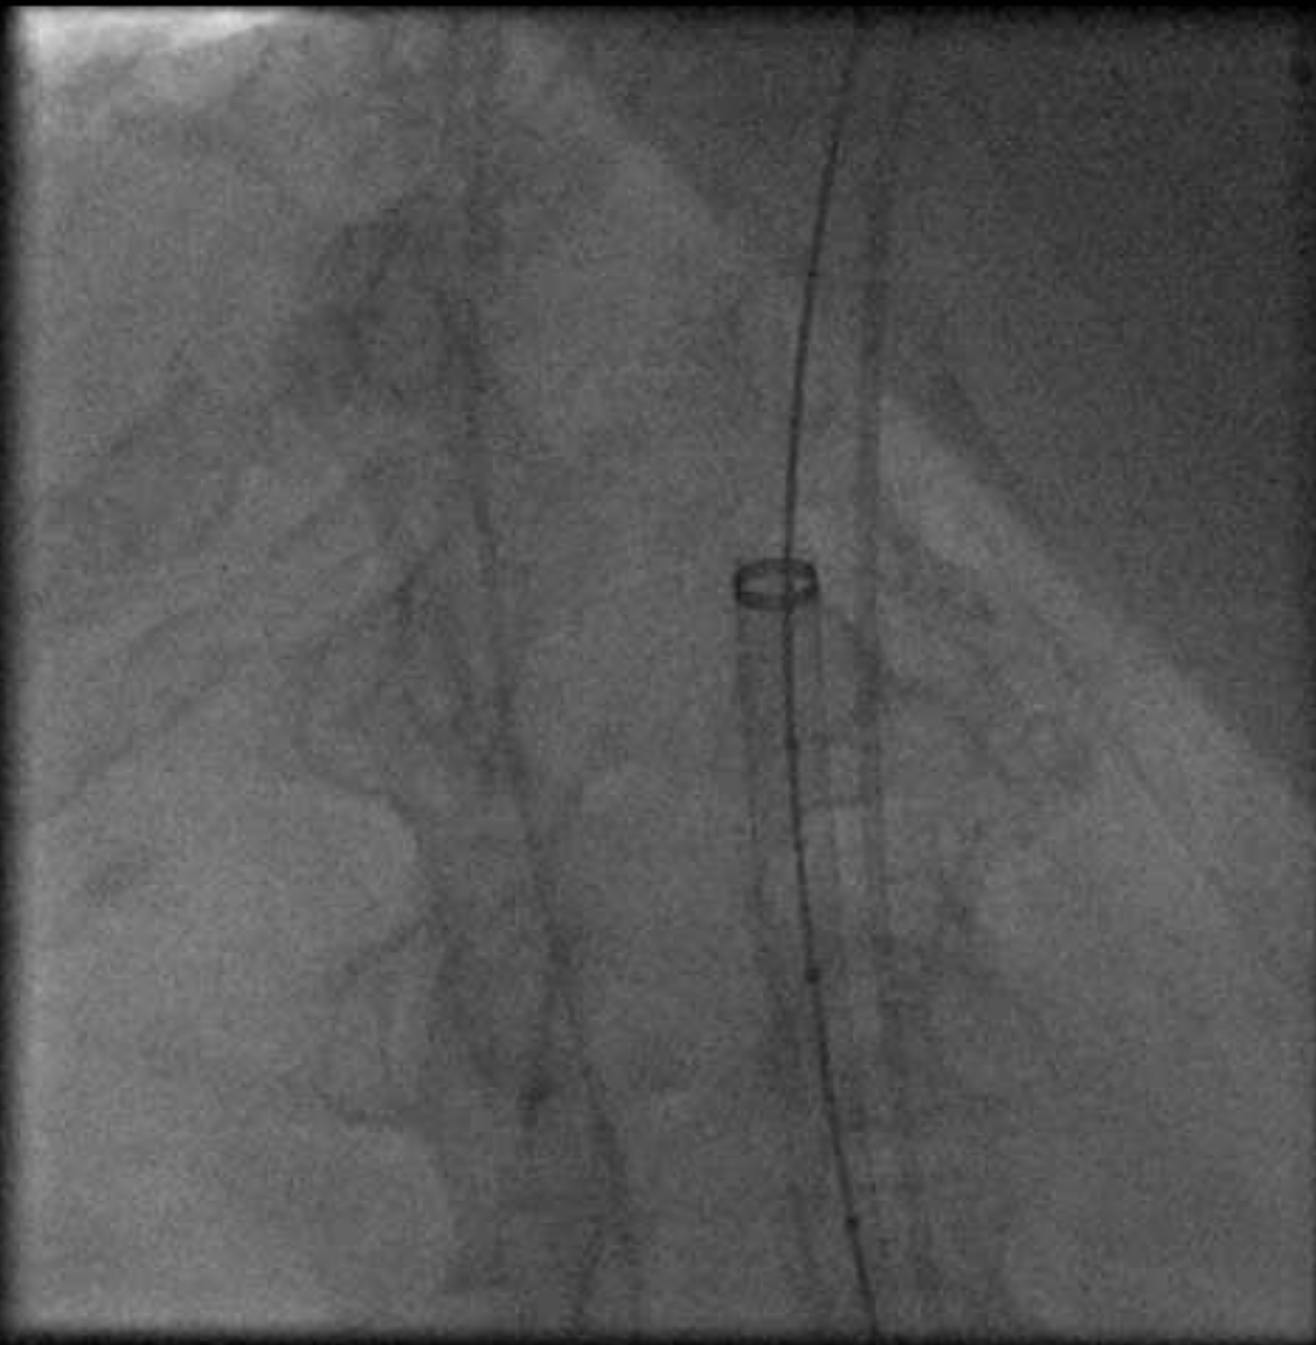
Withdrawal
of ruptured
Balloon

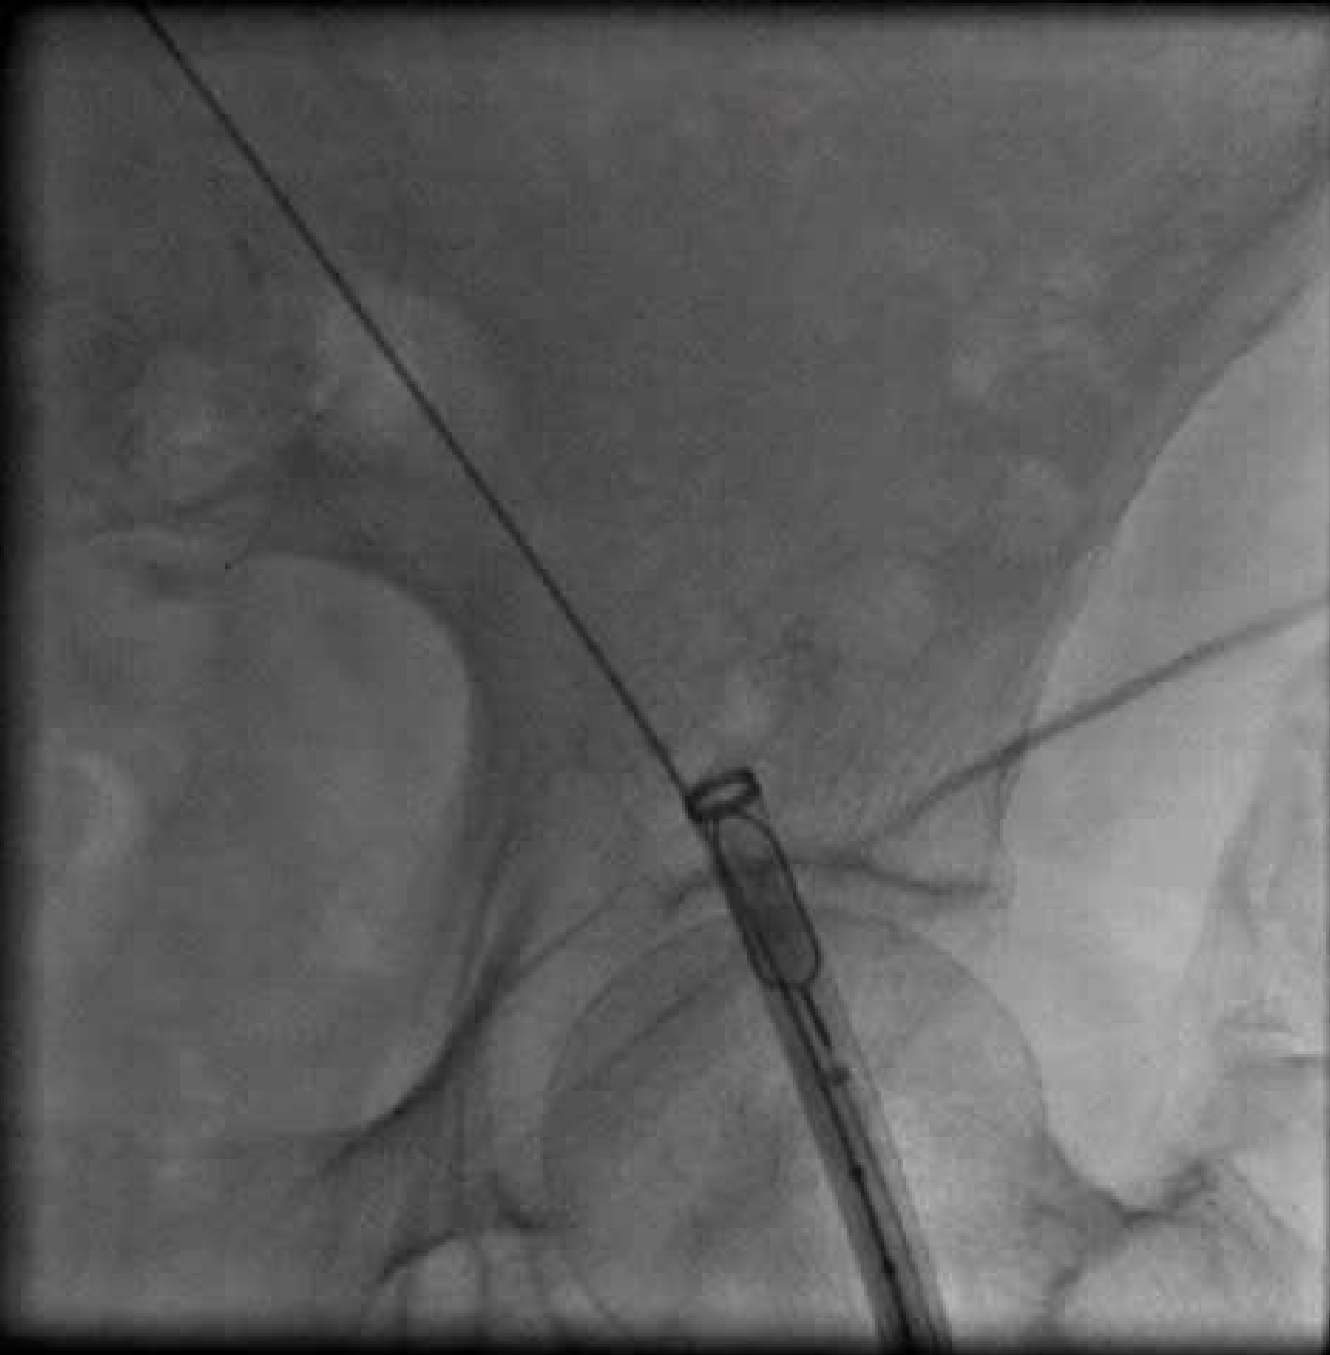
Pull back of
Balloon and
Sheath with
Snare Support

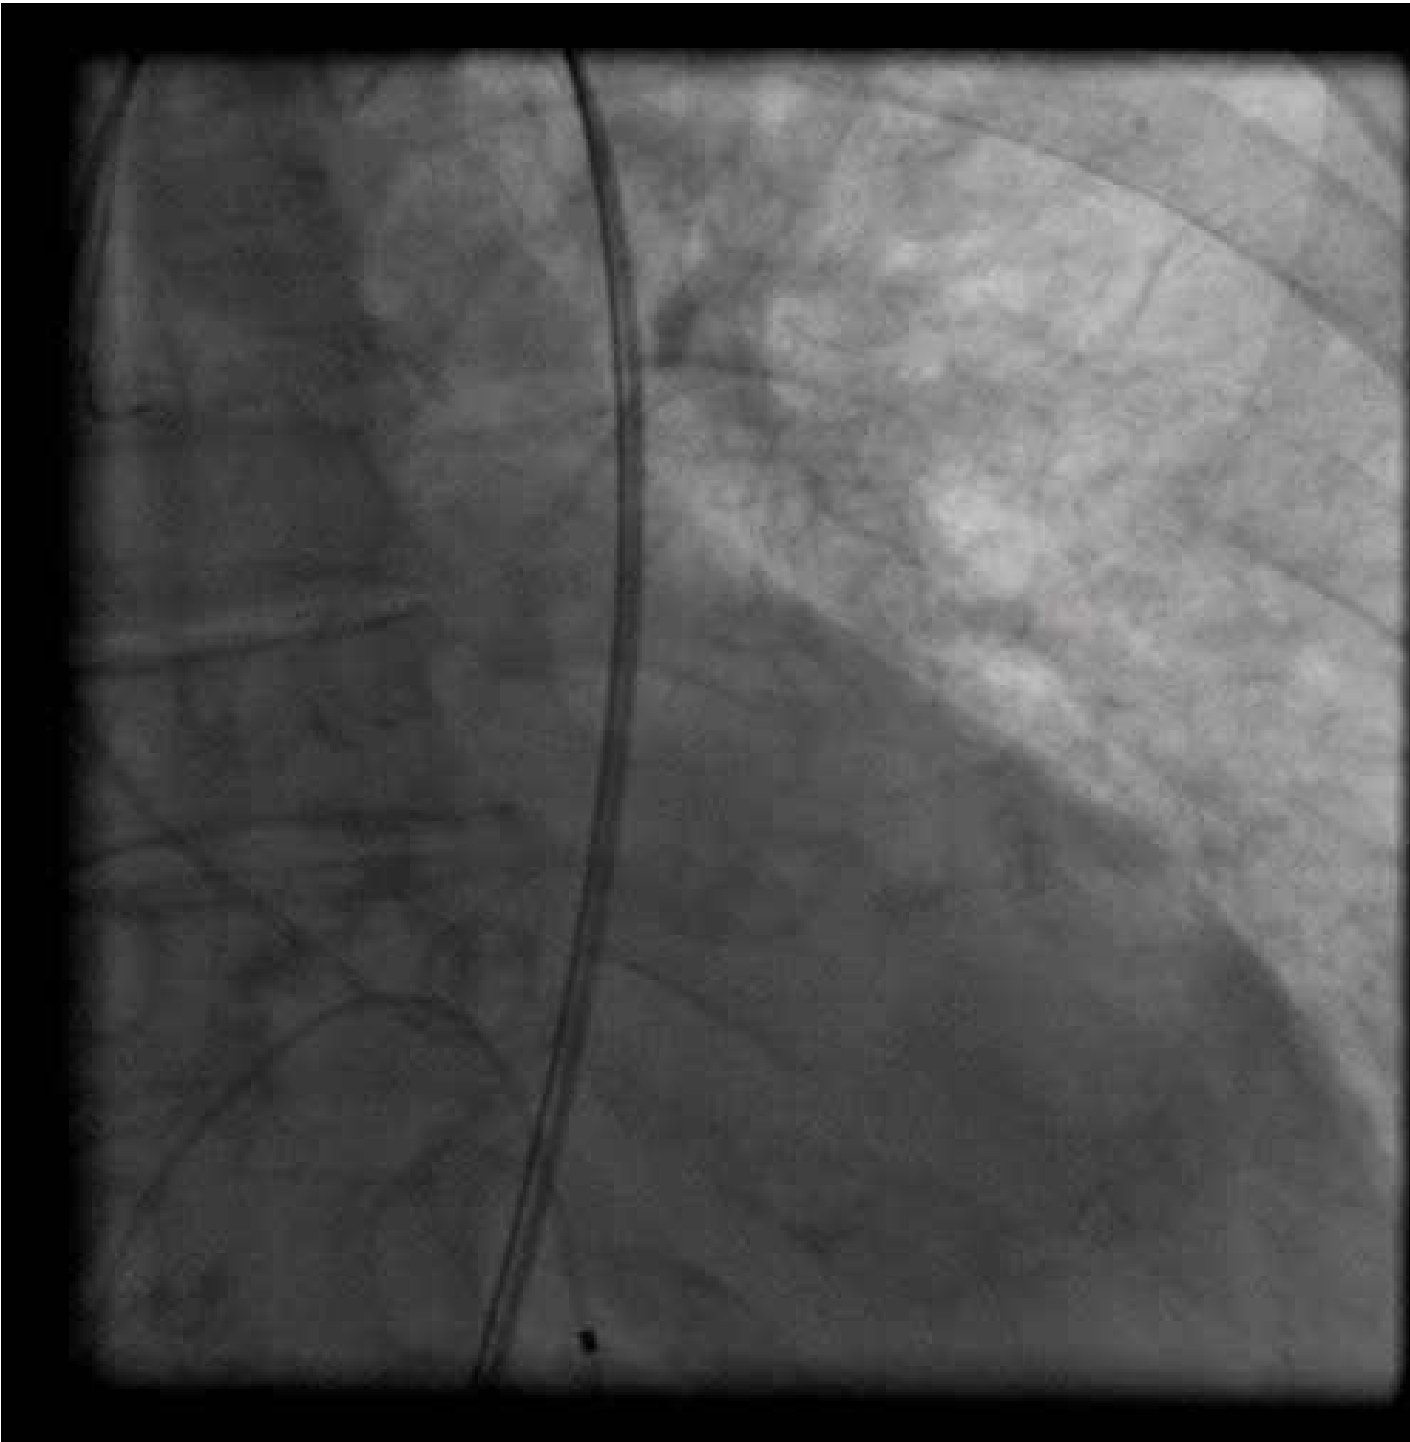
Aortogram –
Patient is
deteriorating,
Cardiac
Depression,
Hypotension

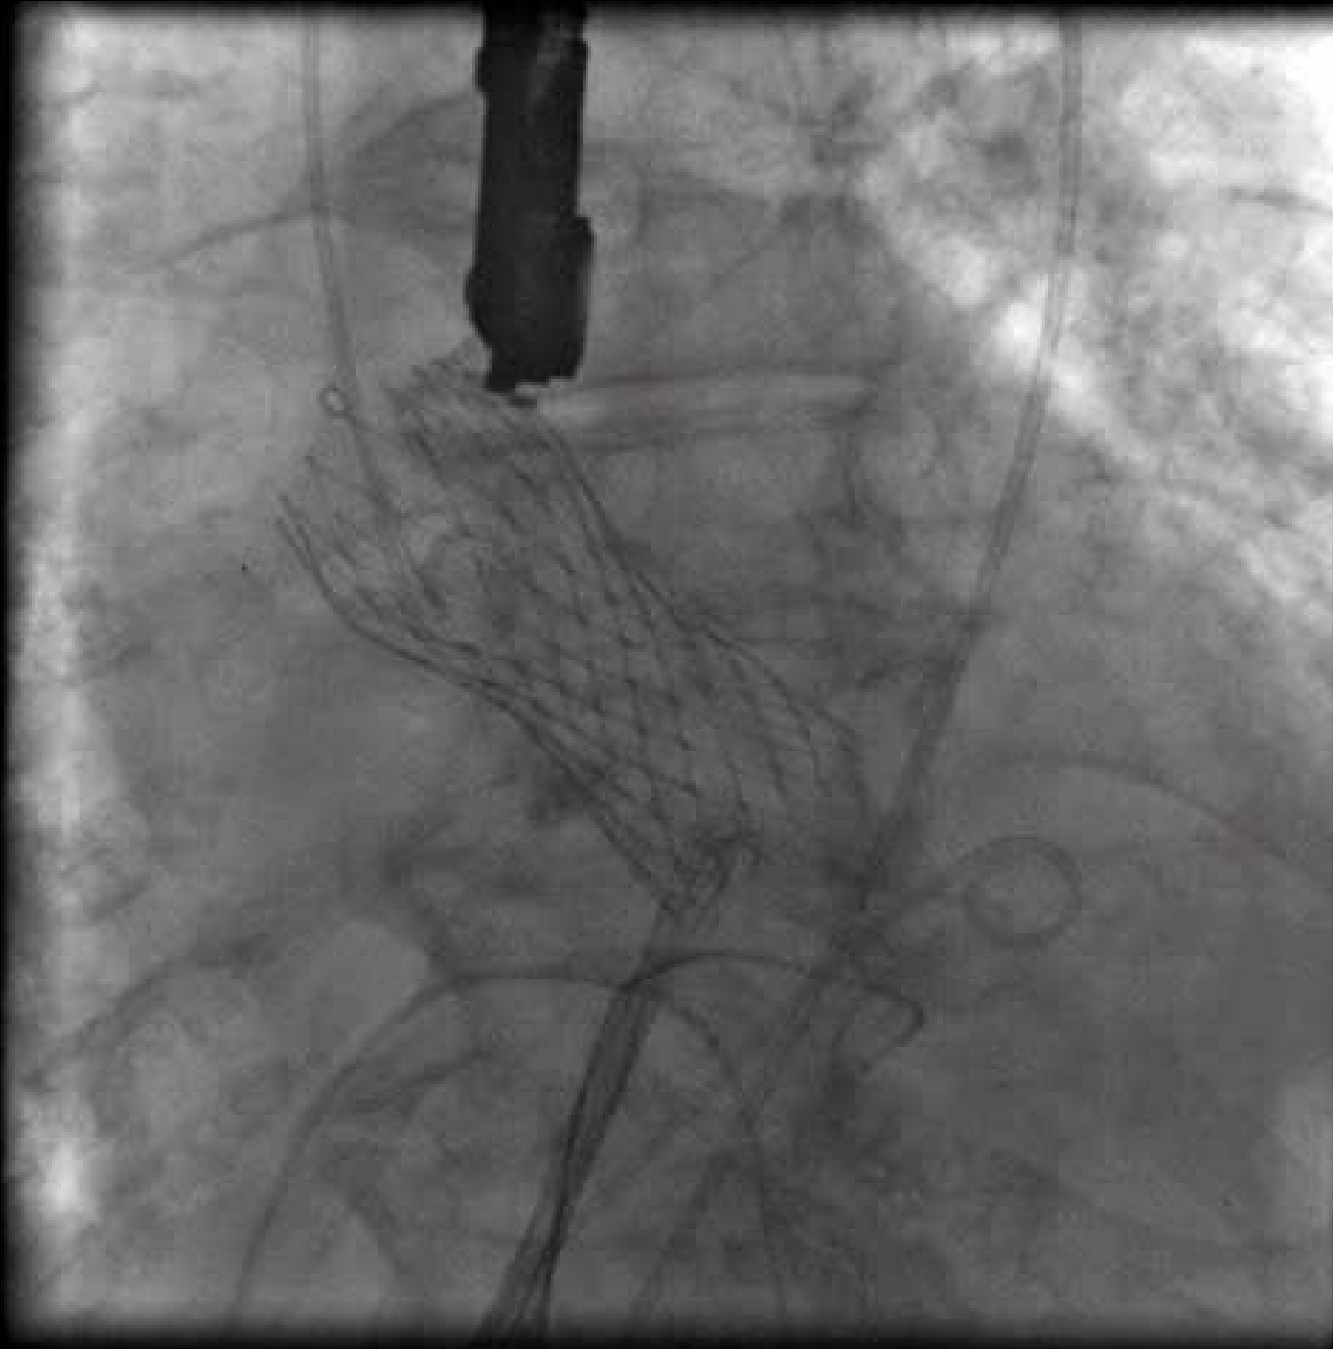
Good
angiographic
final Result
